**Flood Control Project Maintenance
Levee Inspections****2012 Channel Summary Report****Overall Unit and Item Ratings****DWR Sutter Maintenance Yard**

Flood Control Project Maintenance**Unit Cover Sheet****2012 Channel Inspection Results****DWR Sutter Maintenance Yard**

Channel
Big Chico Creek

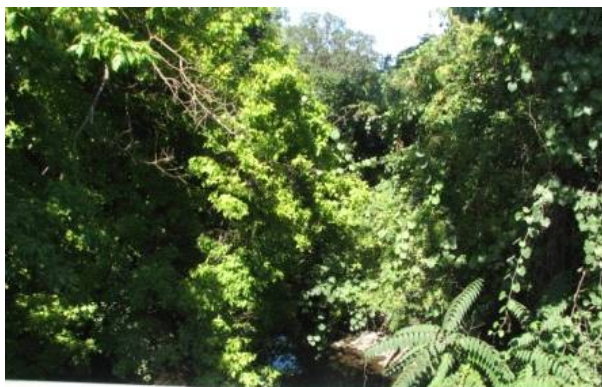
Levee Mile Report Line	41
Start Levee Mile	0.00
End Levee Mile	0.00
Location	
Category	Channels
Item	Vegetation & Obstructions

This photo is looking upstream from Highway 32 bridge, the vegetation obstructed the view for revetment inspection.

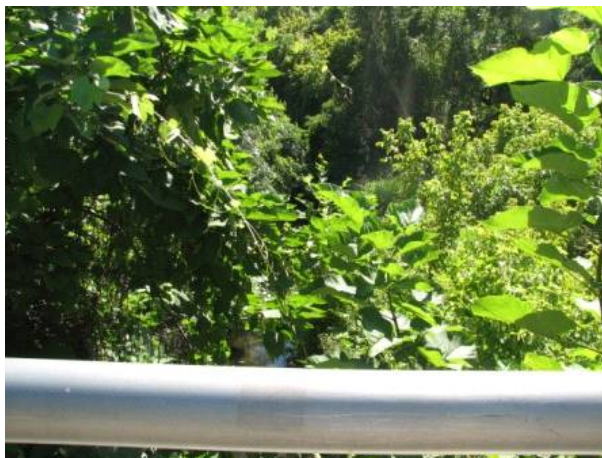
Levee Mile Report Line	46
Start Levee Mile	0.00
End Levee Mile	0.00
Location	
Category	Channels
Item	Vegetation & Obstructions

This photo is looking downstream from Highway 32. The vegetation obstructs the view for revetment inspection.

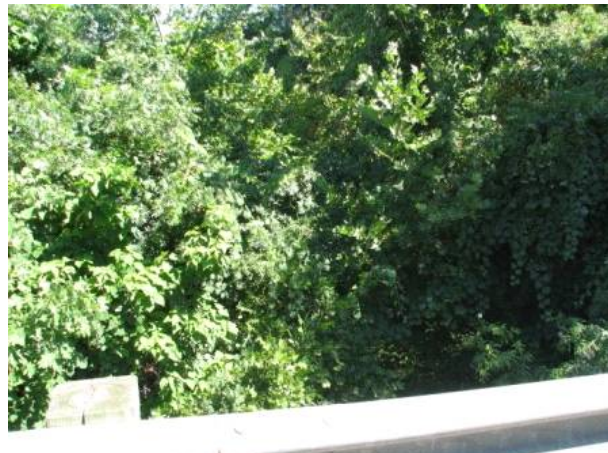
Levee Mile Report Line	74
Start Levee Mile	0.00
End Levee Mile	0.00
Location	
Category	Channels
Item	Revetments
Unwanted vegetation obstructs the channel, this photo is the upstream side of Oak Ave. bridge.	
cathom_c_20120808_079.JPG

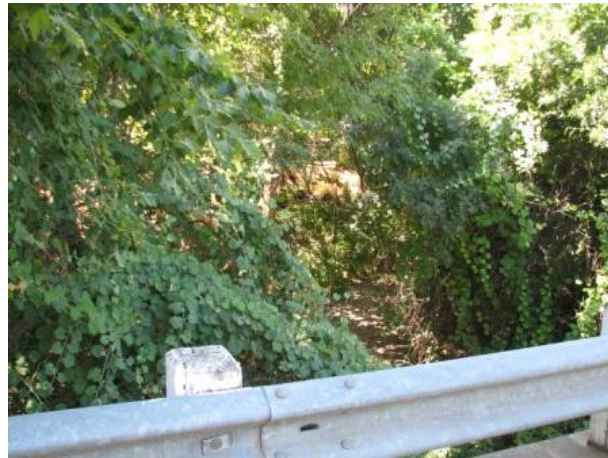
Levee Mile Report Line	79
Start Levee Mile	0.00
End Levee Mile	0.00
Location	
Category	Channels
Item	Revetments
<p>This photo is looking at the channel from the downstream side of the Oak Ave. bridge.</p> <p>cathom_c_20120808_080.JPG</p>

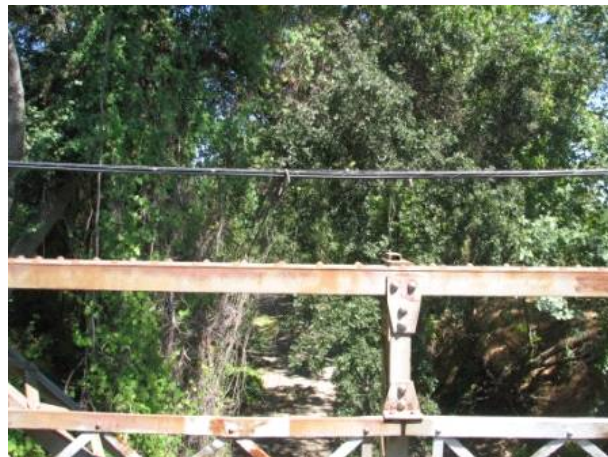
Levee Mile Report Line	84
Start Levee Mile	0.00
End Levee Mile	0.00
Location	
Category	Channels
Item	Revetments
<p>This photo is looking upstream at the channel from the Grape Way bridge. Vegetation obstructing the view should be removed.</p> <p>cathom_c_20120808_081.JPG</p>

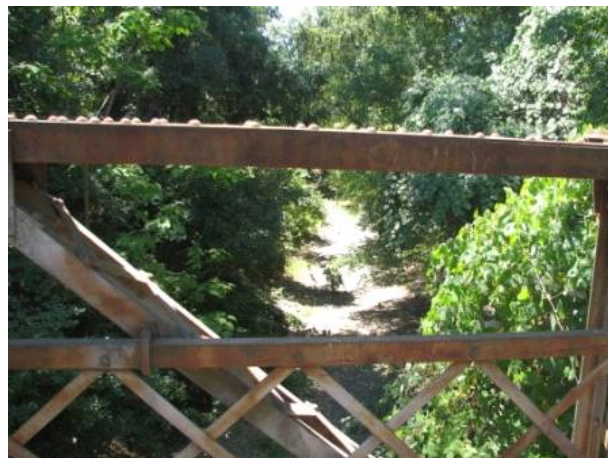
Levee Mile Report Line	89
Start Levee Mile	0.00
End Levee Mile	0.00
Location	
Category	Channels
Item	Revetments
<p>This view is looking downstream at the channel at the Grape Way bridge. Vegetation obstructing the view of revetment should be removed.</p> <p>cathom_c_20120808_082.JPG</p>

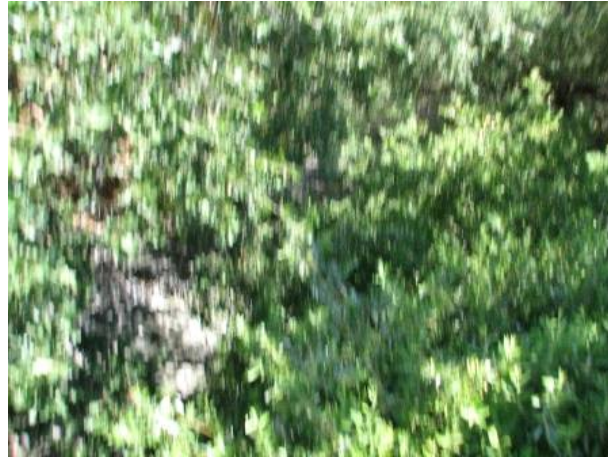
This photo is looking upstream from Bruce Road bridge. Vegetation obstructed the view of the channel.

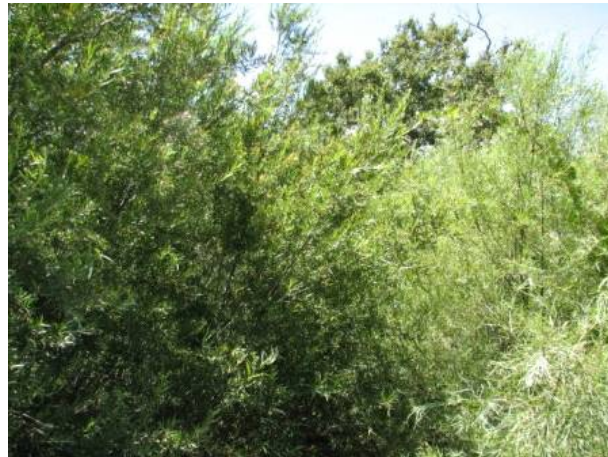
Levee Mile Report Line	16
Start Levee Mile	0.00
End Levee Mile	0.00
Location	
Category	Channels
Item	Vegetation & Obstructions

This photo is looking downstream from Bruce Road bridge. Vegetation obstructed the view of the channel.

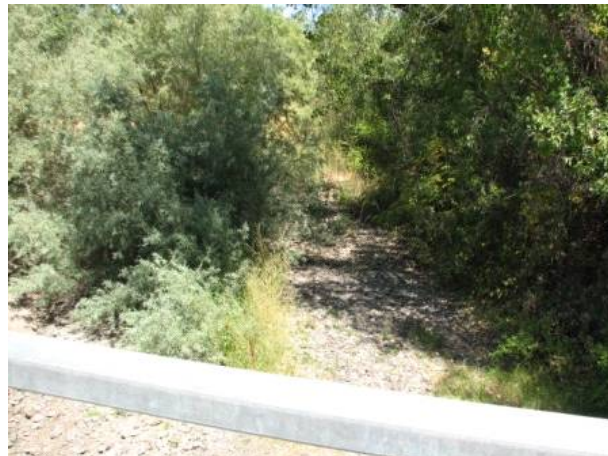
Levee Mile Report Line	21
Start Levee Mile	0.00
End Levee Mile	0.00
Location	
Category	Channels
Item	Vegetation & Obstructions

This photo is looking upstream from Forest Avenue bridge. Shoaling and vegetation in the channel.

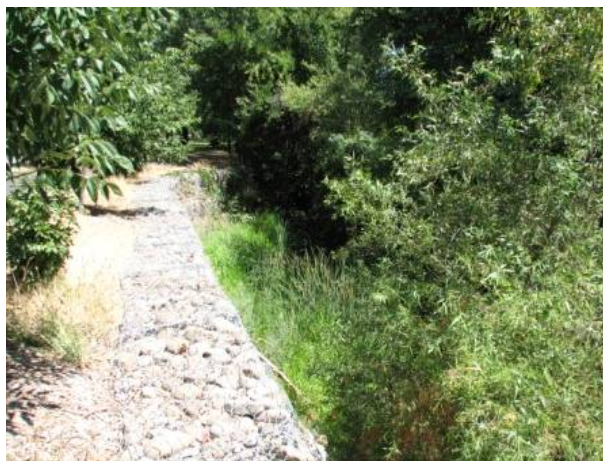
Levee Mile Report Line	31
Start Levee Mile	0.00
End Levee Mile	0.00
Location	
Category	Channels
Item	Vegetation & Obstructions

This photo is looking up stream at the erosion repair site, up stream from Highway 99 on Humboldt Road. There is vegetation in the channel, the flow in the channel does not appear to be impeded.

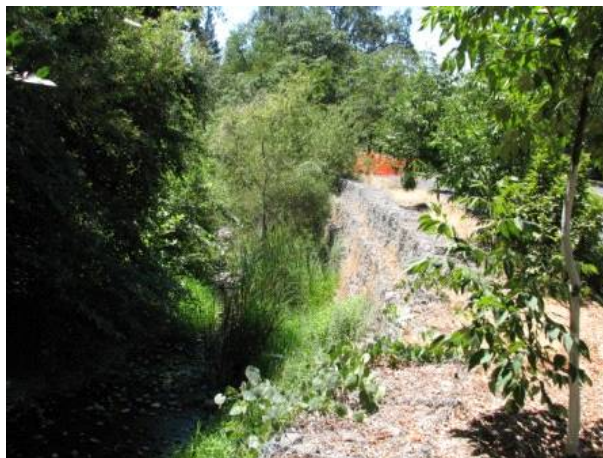
Levee Mile Report Line	36
Start Levee Mile	0.00
End Levee Mile	0.00
Location	
Category	Channels
Item	Vegetation & Obstructions

This photo is looking downstream at the erosion repair site, down stream of Highway 99 on Humboldt Road. There is vegetation in the channel, the flow does not appear impeded.
